# Pennsylvania Ave. Water Main Break

## CASE STUDY

Consequences of pipeline failure of an 8-inch water main on the 4700 & 4800 Blocks of Pennsylvania Ave.

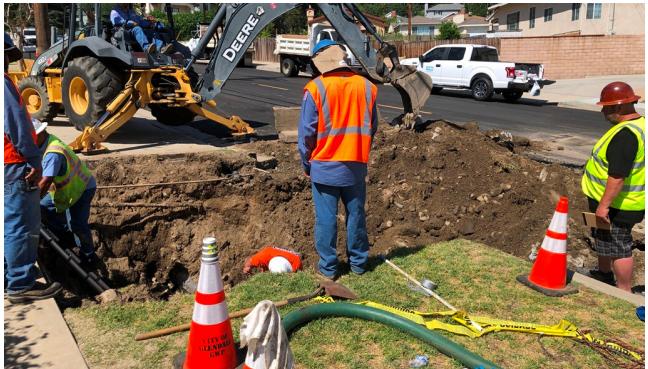
On August 4, 2019, CVWD experienced a major water main break on an existing 8-inch pipeline on Pennsylvania Ave. between El Caminito Street and Stevens Street that was installed in 1946. The water main break started about 2:00 am and water from the pipeline was isolated by 8:00 am. As a result of the water main break:

- 925,000 gallons of water was lost
- 15 homes were without water
- Damage to the plumbing at house near main break.
- Excessive damage to the pavement on Pennsylvania Ave from El Caminito Street to Fairesta Ave.
- Road closure of a portion of the street to traffic
- Increased paving costs as Pennsylvania Ave. was recently re-paved by the City of Glendale and there was a five-year moratorium for new construction on the street

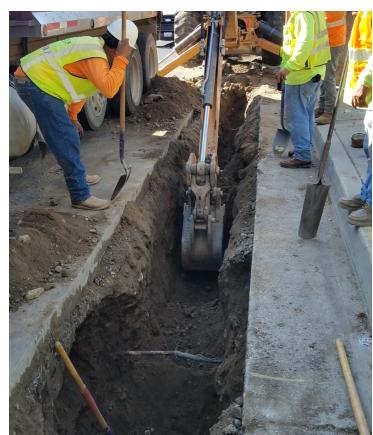
- Field crews repaired the leak with a repair clamp to restore water service in the area. However, there were additional leaks on the pipeline that were revealed when water was being restored.
- The condition and age of the pipeline warranted its replacement in this emergency situation and CVWD could take advantage of replacing the pipe during the pavement restoration.
- CVWD would have to repair about 23,000 SF of pavement to get the roadway back into condition for normal traffic on Pennsylvania Ave.

CVWD worked with Los Angeles County and City of Glendale personnel to determine the extent of pavement area that would need to be replaced in the short-term. CVWD contracted with a paving construction contractor to repair the roadway.

Pennsylvania Ave. was repaved and repaired within two weeks after the event and traffic was returned to normal. In addition, CVWD coordinated the pavement work with the start of the 2019-20 school year and provided detour routes for dropping off school children.
